Post-Tensioning Technology Exchange

Outcomes Report

May 2023

RPT NO FHWA-PL-23-009

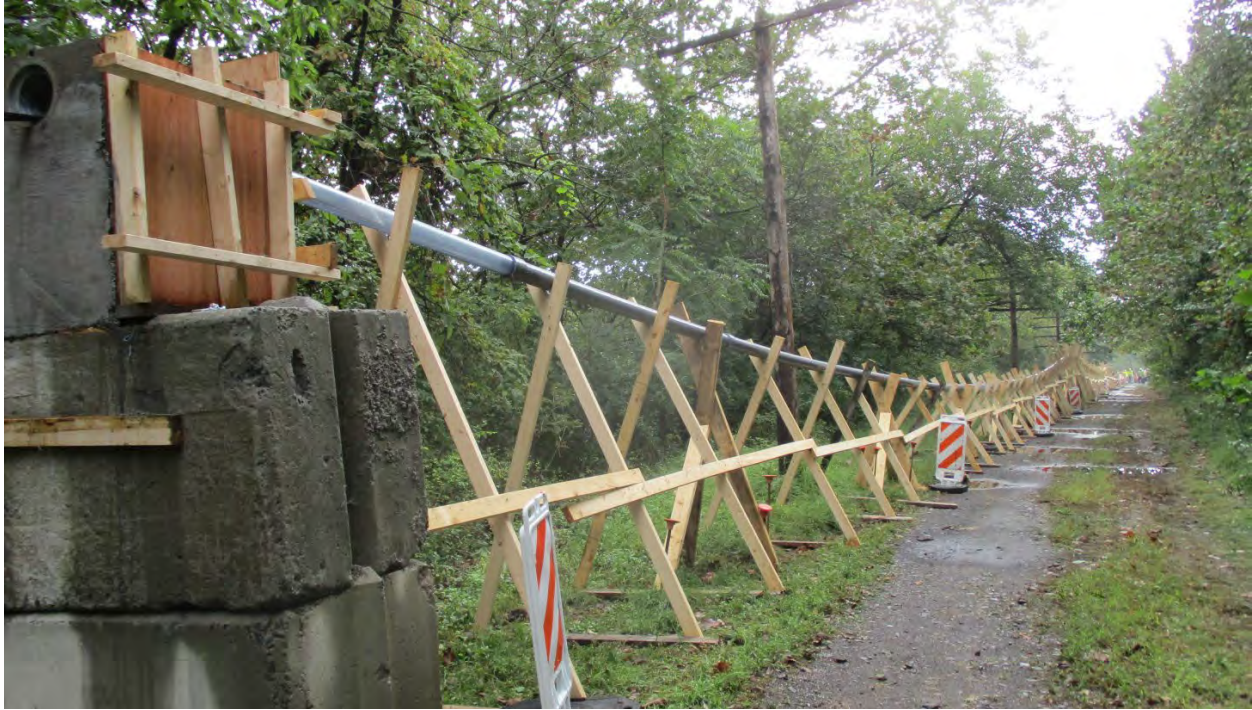
Figure 2: A mock-up built at the construction site of a single PT strand. (Source Dr. Clay Naito)

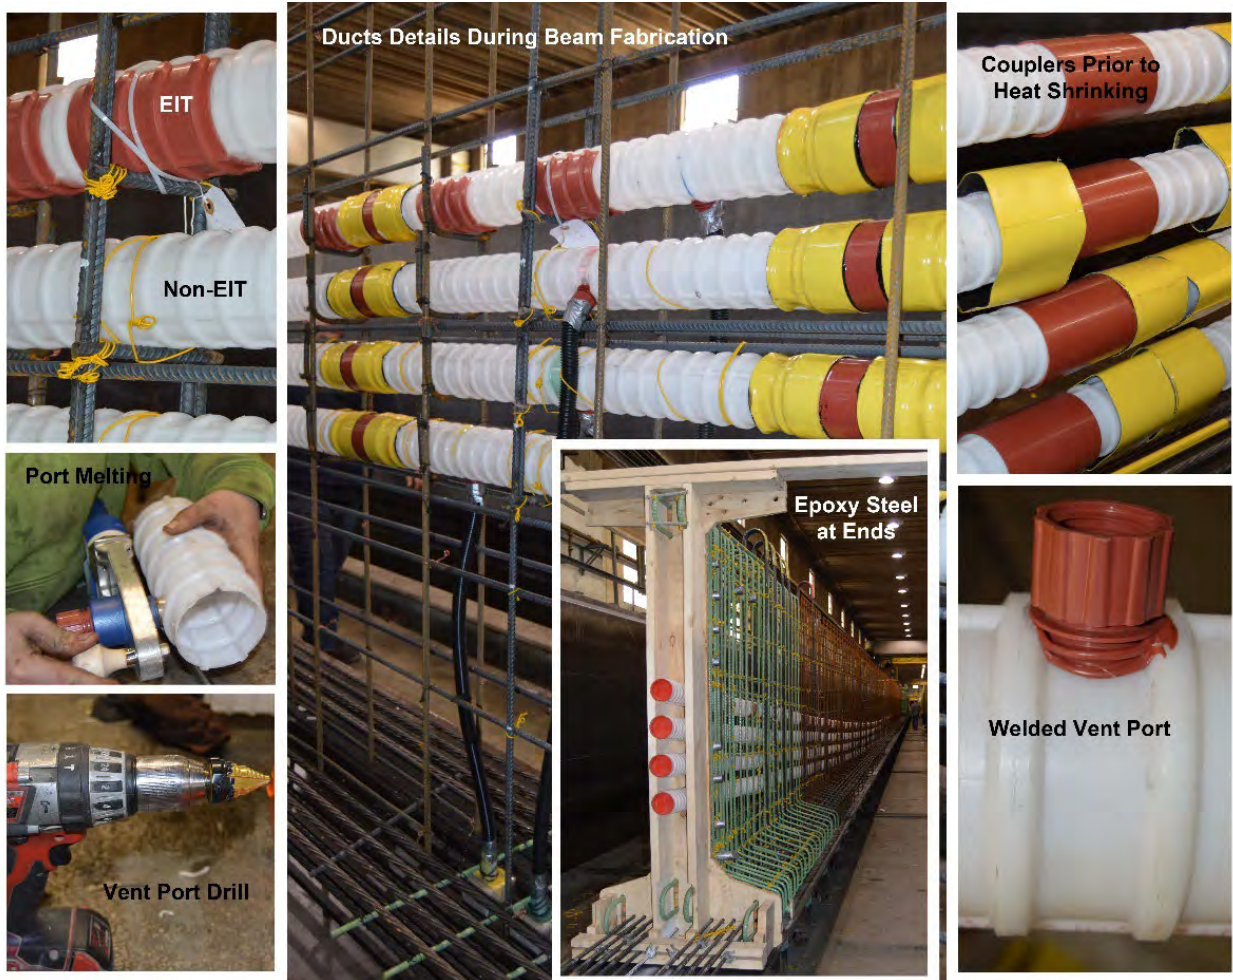
Figure 4: The various ducts and ports necessary for the implementation of the electrically isolated tendons. (Source: Dr. Clay Naito)

The LCR monitor used was an 880 B&K and measurements were taken at 0.6 volts with a frequency of 1kHz and with the LCR meter set to parallel. The measurements were taken at the following times: 1) after tensioning and prior to grout, 2) after grouting, 3) 28 days after grouting, and 4) at long term intervals. Images of the components fabricated prior to construction and the general outline of the measurement system are provided in **Figure 4** and **Figure 5**.

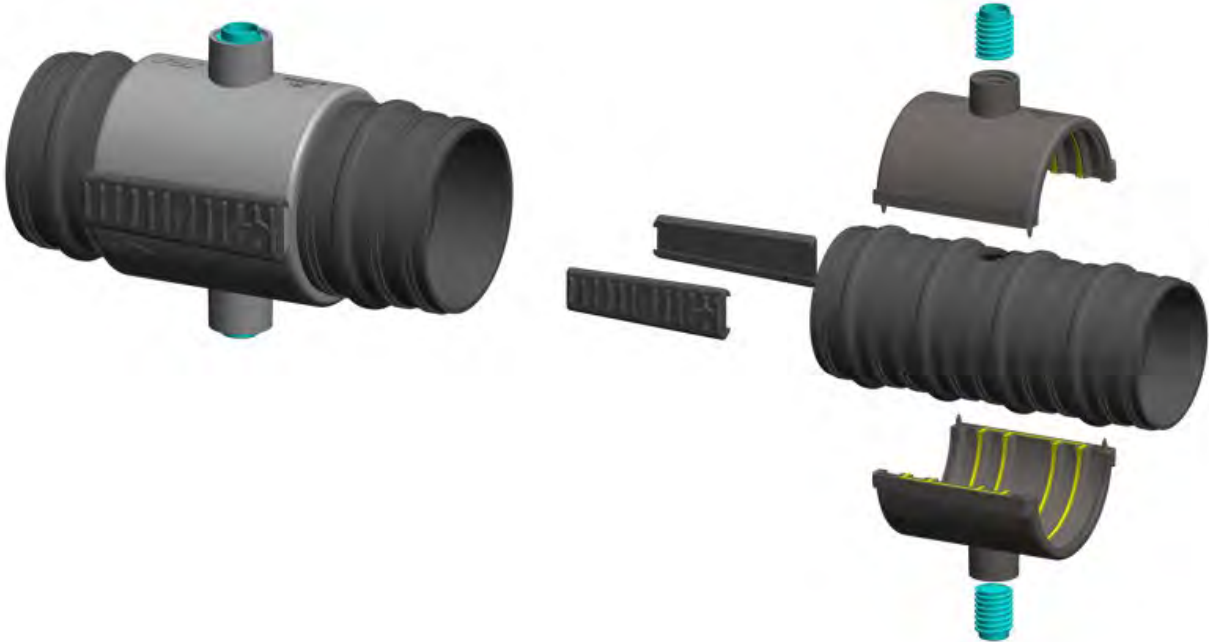
Figure 8: Schematic of the VCsensor placement along the duct of a tendon. (Source: VSL International)

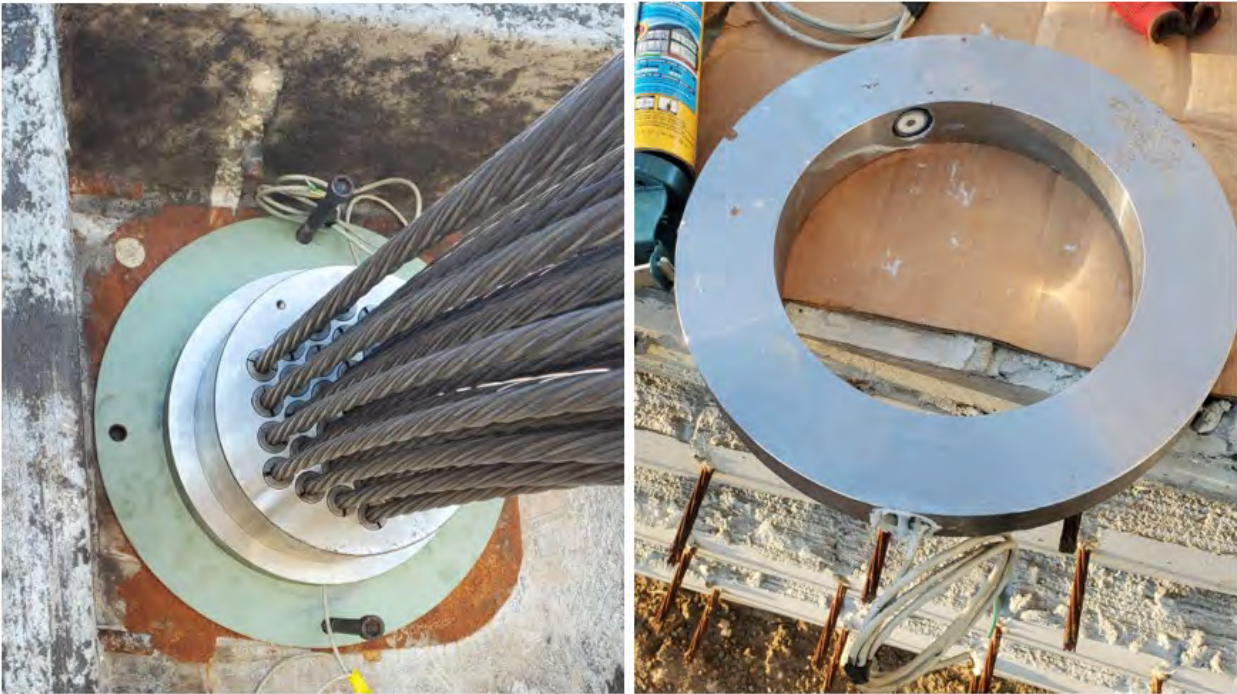
Figure 9: Field implementation of the VCensors. (Source: VSL International)

These sensors have been tested both in published research and in the field. At the Exe Viaduct in the United Kingdom, 24 sensors were installed and allowed the contractor to forego a grout mockup due to the sensors enabling verification of the effectiveness of the grouting operation. The sensors have also been applied in the Cross Bay Link in Hong Kong where 2500 sensors have been installed at anchorages, and along the SH 146 in Houston where they are applied post-construction behind the anchor heads, avoiding the need for drilling into the anchorage, and can be removed to allow for visual inspection of the grout.

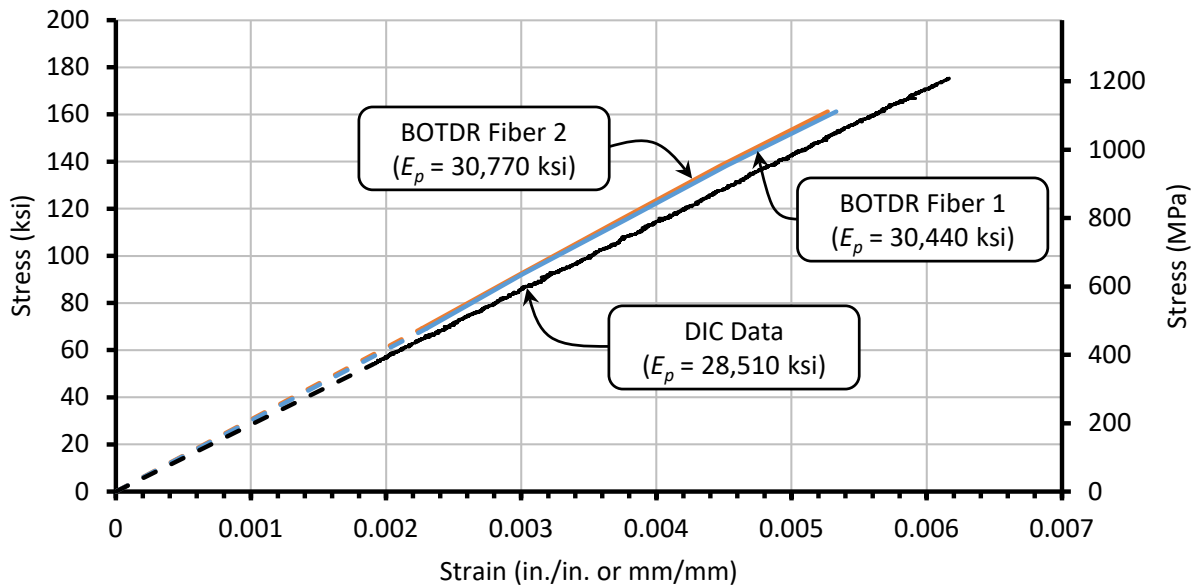
Figure 13: Tensile test results showing the difference between BOTDR and DIC results. (Source: Purdue University)

To help validate the system, the research team conducted tensile testing on the optical fiber sensor-embedded PT strands and correlated the elastic modulus obtained through digital image correlation (DIC) data and the load data output from the universal testing machine with the value provided by the BOTDR analysis (**Figure 12**). Within the linear range, this testing resulted in a correction factor of approximately 0.95 that can be used to correlate the strain indicated by the BOTDR module and the longitudinal strain along the length of the strand (**Figure 13**). Week-long testing was also conducted for these optical fiber sensor-embedded PT strands, with these results also indicating a sufficient level of accuracy for the BOTDR data. Future consideration includes structural tests on girder specimens in the laboratory, developing analytical models for further assessment of the optical fiber strain data, and providing recommendations for its implementation in the field.

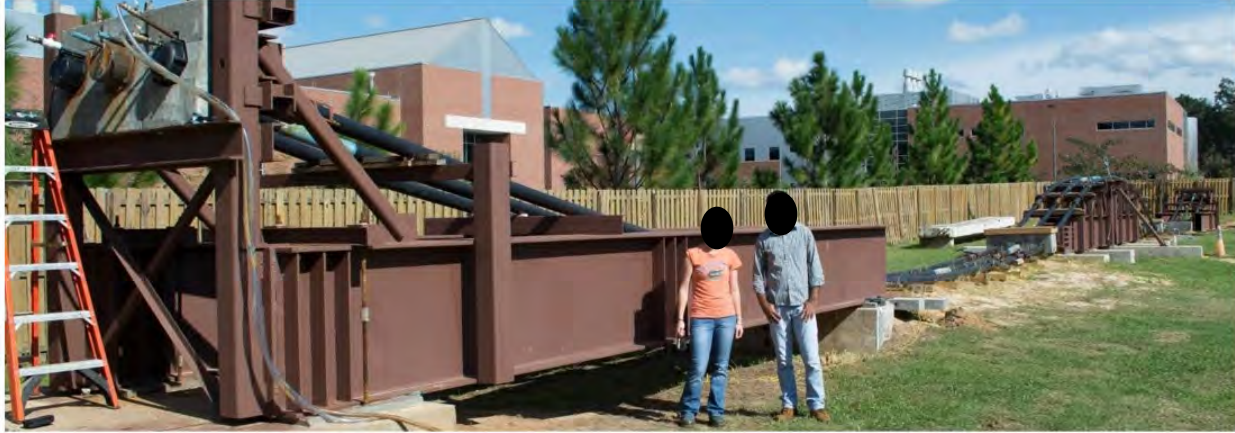
Figure 14: 200' profile injection mock-up for testing of wax-filled tendons along with the outline of the design in the lower portion of the image. (Source: FDOT)

FDOT and the University of Florida (UF) developed an injection mock-up, which included a 200' total profile, with two "external" sections of 70', and a single "internal" section of 60' (**Figure 14**). This mockup had light tension on the tendon within the duct, and wax was injected into the duct at a rate of 40'-70'/min. This system requires that heat-shrink wrap not be used at external duct connections due to softening of the material, and metal vents and outlets must replace all plastic components. The injection utilizes a vacuum-assisted process that requires the ability to achieve a 90% vacuum within the tendon, to ensure a quality sealed system (see **Figure 15** and **Figure 16** for additional flexible filler details).

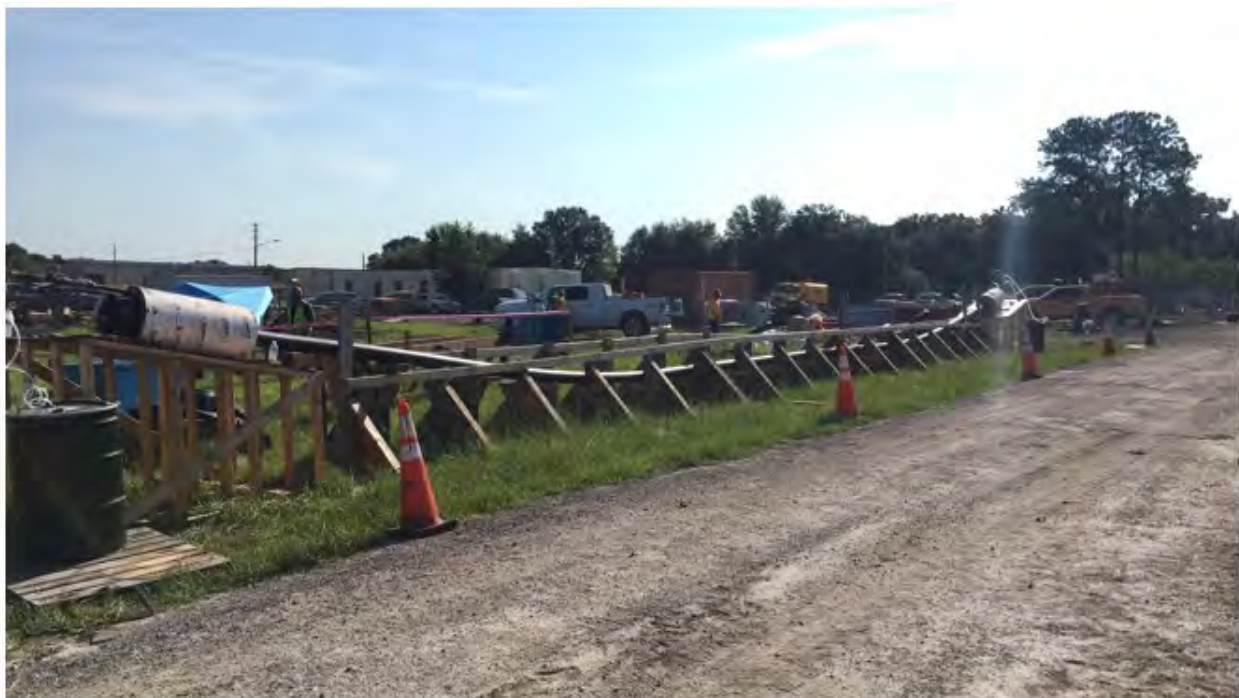
Figure 17: Pre-construction tendon mock-up (Source: FDOT)

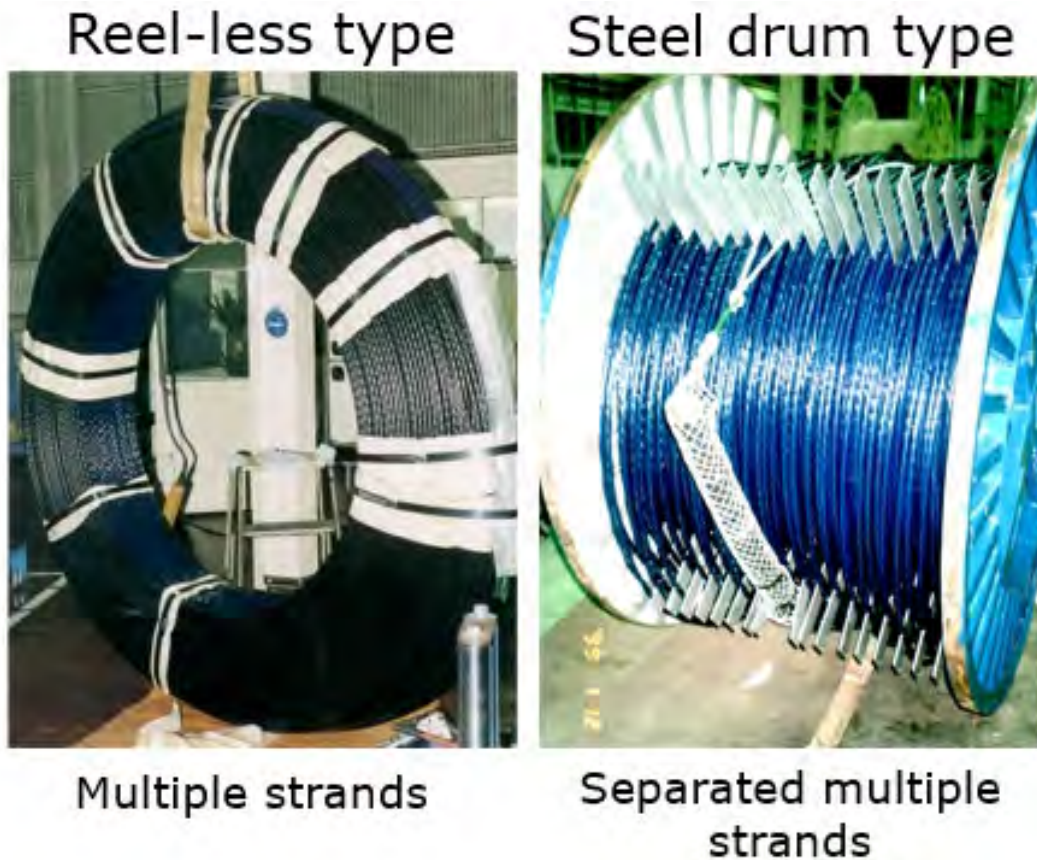
Figure 19: Illustration. Reel-less strands and Steel drums for transportation of the epoxy coated strands. (Source: Sumiden Wire Products)

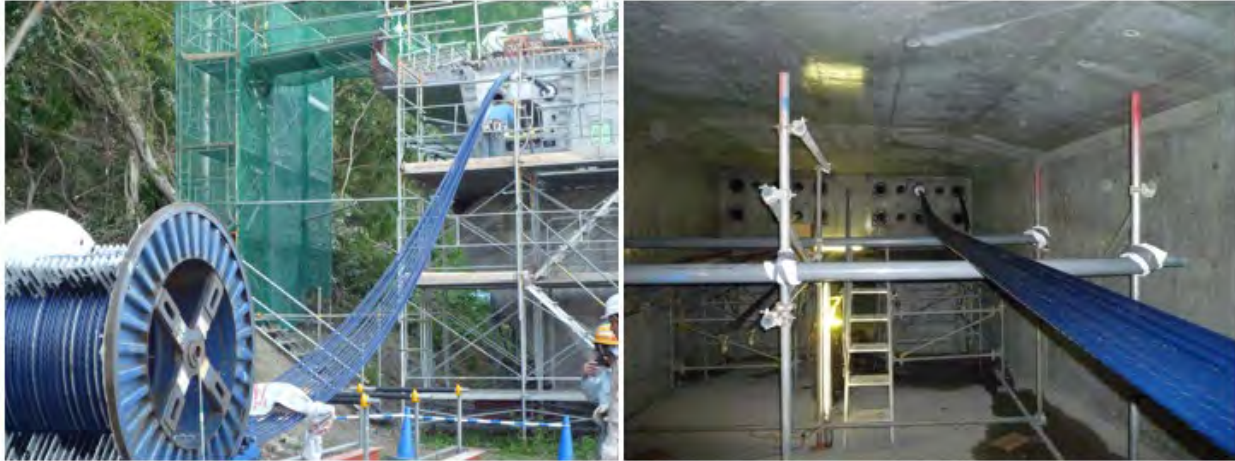
Figure 20: Epoxy-coated strand being unwound and pulled through the ducts during construction. (Source: Sumiden Wire Products)

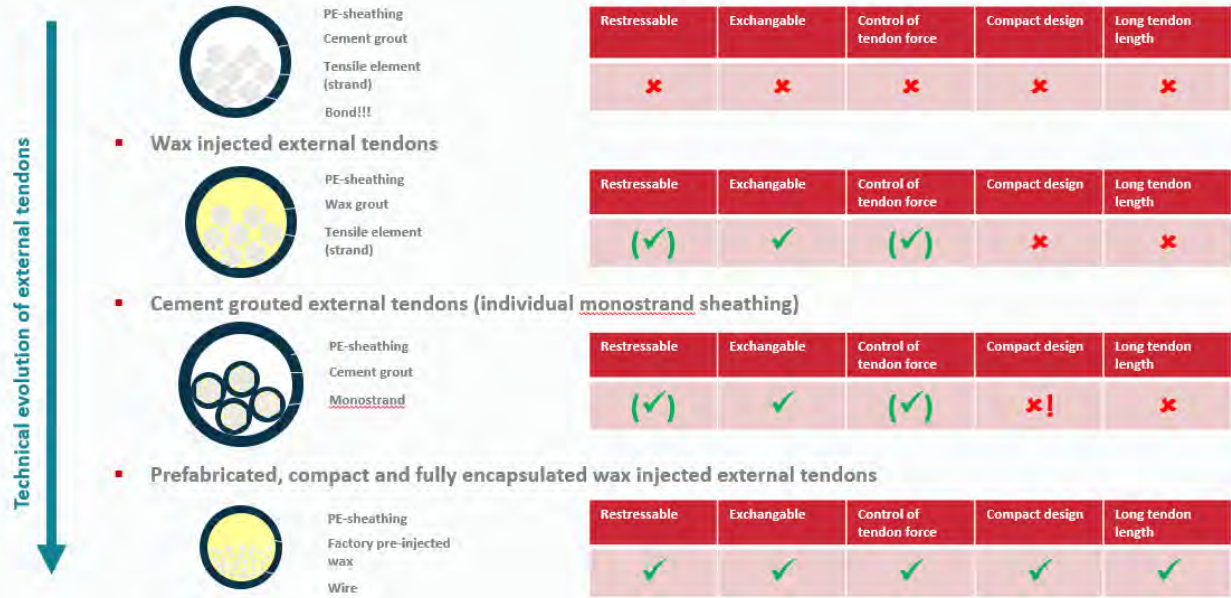
Figure 21: This table details the various external tendon and filling types along with the potential advantages and drawbacks of each (Source: DYWIDAG)

Dr. Glaeser began with a general overview of the PT concepts and external tendon types with various corrosion protection methods. He also provided an evolution of external tendon systems and filling types with variable pros and cons (**Figure 21**). First generation (grouted) external tendons have been experiencing issues, including cracked PE ducts, grout voids, and tendon corrosion. When corrosion leads to failure in one tensile element, the tensile load is then transferred via bond to the remaining tensile elements, increasing risk of tendon failure. To mitigate the possibility of corrosion, countries have adopted varying policies, like prohibiting cement grout (France 2001, Florida 2016) or adopting epoxy coated strands (Japan). European policies have been revised to require replaceability for external tendons, with several countries requiring the ability to adjust tension of the tendons post-construction.

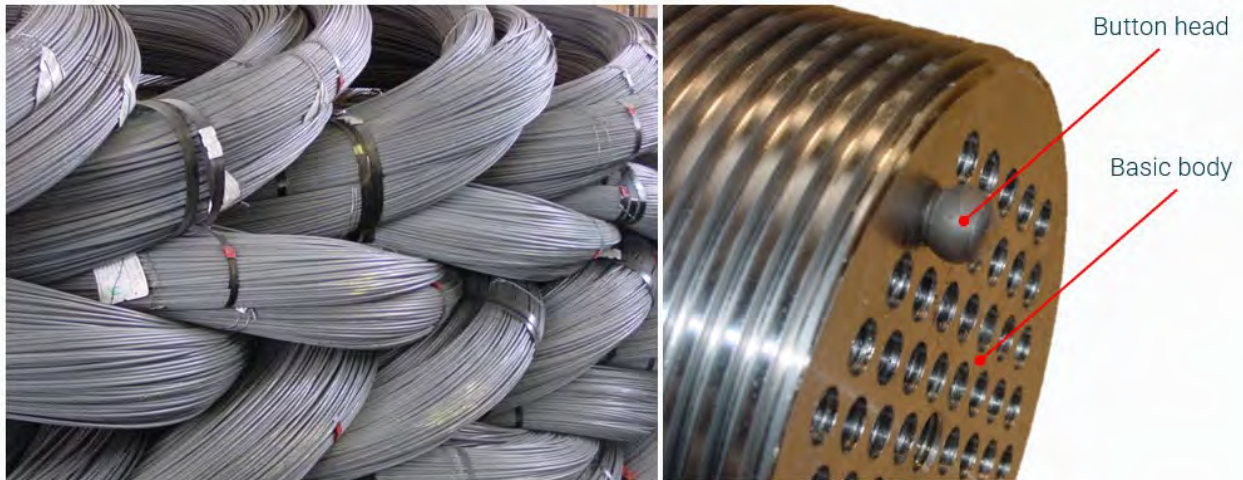
Figure 22: An example of a prefabricated tendon (Source: DYWIDAG)

Dr. Glaeser then laid out the various types of external tendons that use flexible fillers and have various levels of prefabrication. Tendons assembled on-site are the most flexible and frequently used. They can use standardized and lighter equipment, the components are delivered separately to the construction site; but they have major drawbacks of being on the critical path of the bridge construction. In addition, corrosion protection is applied on site which can lead to unreliable performance and weather dependencies. Partial or semi-prefabricated tendons have a corrosion protection of the free length applied under constant conditions, adaptable tendon lengths, and final assembly and connection is to the anchorages on site. Their major drawbacks are that prefabricated corrosion protection is limited to the free length and coiling and transportation limit the size and length of the tendons. For fully prefabricated tendons, the tendon along with anchorages are prefabricated and connected with a PE duct. Fully prefabricated tendons have the most reliable corrosion protection which is applied under factory conditions, and they are shipped to the site prior to installation. Their major drawback is that length adjustability on site is limited so exact tendon length must be determined prior to fabrication.

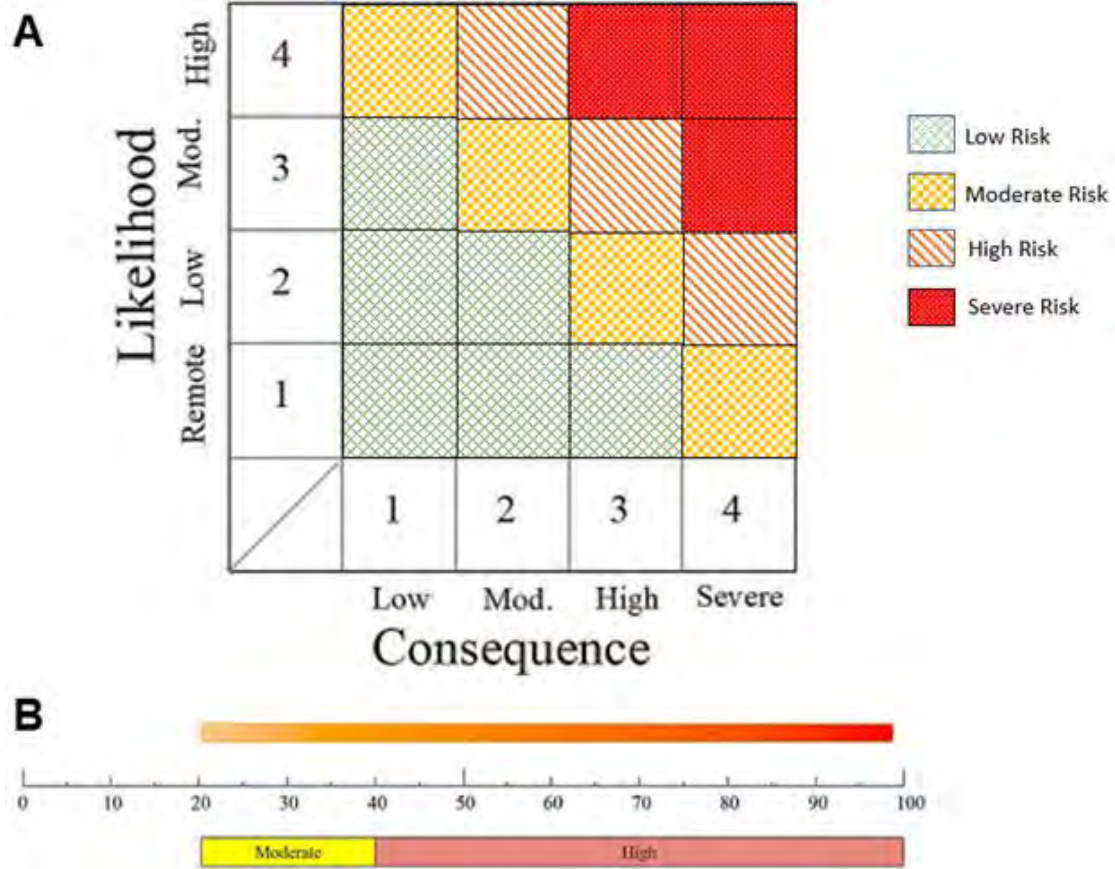
Figure 25: (A) shows an example of a risk matrix and (B) shows an example of a risk scale (Source: FHWA)

Dr. Washer aims to apply the risk-based decision-making process to the goal of improving the durability of PT bridges. According to Dr. Washer, to evaluate risk on any project, engineers must answer three fundamental questions as part of the Risk-Based Inspection (RBI) process: 1) What can go wrong? 2) What are the chances of the event happening across X timeframe? 3) What are the consequences? Formulaically, this is $R = POF * C$, where R is the risk, POF is the probability of failure, and C is the consequence of the failure. Probability of failure may be defined in terms of likelihood, frequency, or occurrence (i.e., how likely is a certain event to occur). To determine the probability of failure, engineers use failure testing, deterioration models, expert knowledge, or point estimates. Consequences are typically described in terms of either 1) economic impacts, 2) environmental impacts, or 3) safety impacts, and these evaluations may rely on expert judgement. Risk may be visually represented using either a risk scale (1-100, with higher values indicating higher risk) or a risk matrix (**Figure 25**). For the risk scale, the risk factor can be expressed by the following: $Risk\ Factor = OF * CF * 100$, where OF (Occurrence Factor) is a measure of the likelihood of the event, and CF (Consequence Factor) is a measure of consequence.

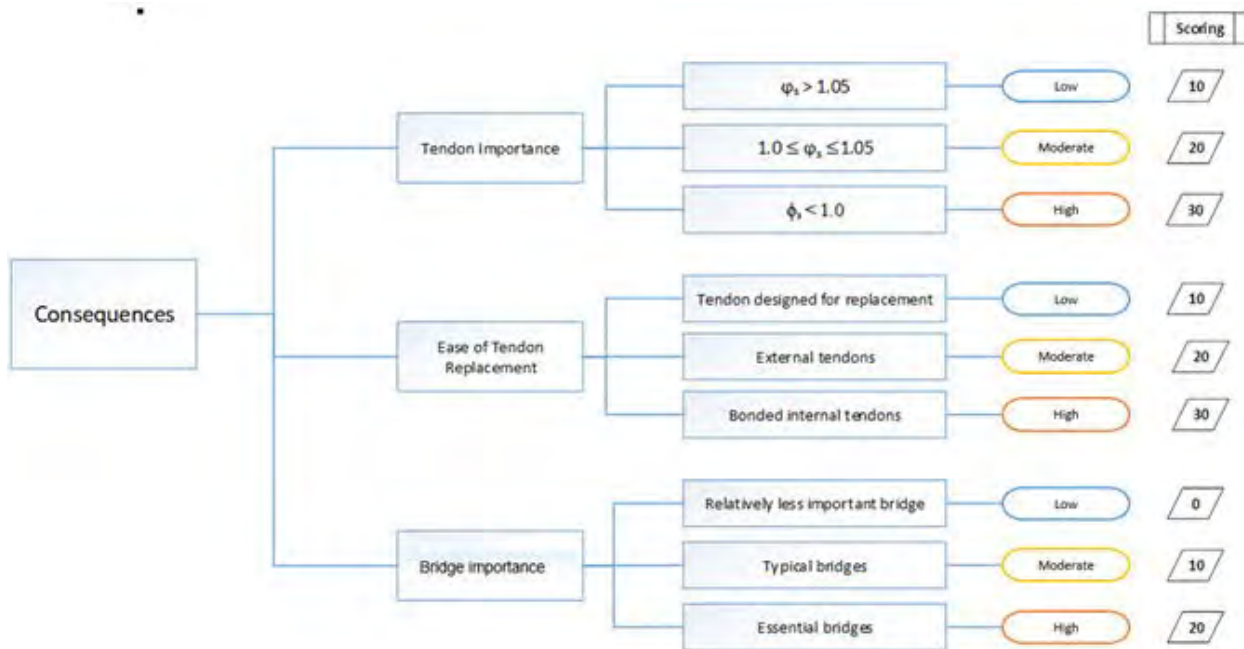
Figure 28: An example of a final scored flow chart for the risk assessment. (Source: FHWA)

To calculate the likelihood of an event, individual attribute scores are summed to provide the relative estimate of the likelihood of corrosion damage: $OF = \frac{\sum S_i}{\sum S_0}$, where S_i is the score recorded for each attribute and S_0 is the maximum score for each attribute. The same process was used to provide a relative estimate of the consequence: $CF = \frac{\sum C_i}{\sum C_0}$, where C_i is the score recorded for each attribute and C_0 is the maximum score for each attribute. The scoring for this system is shown in the flow chart in **Figure 28**.

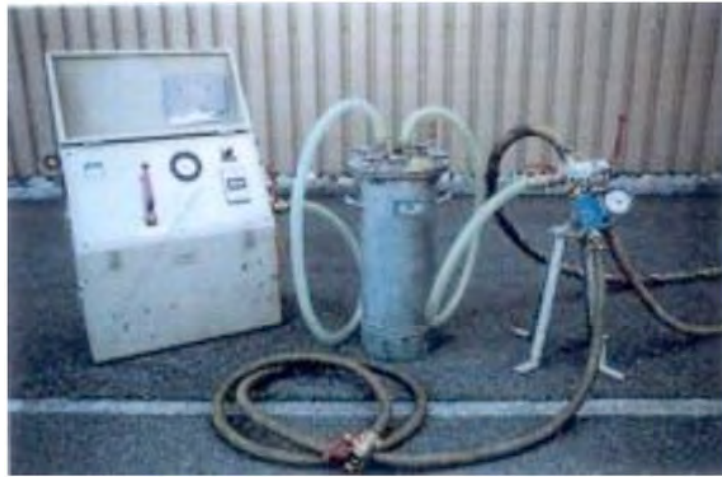
Figure 29: Image of the equipment used for the VAG process. (Source: FIB Bulletin 33 – Fig. 2.22)
